Case Study of Cracks and Its Repairing Techniques

A.Leelavathi¹, Sedhumathavan²

V. CASE STUDY

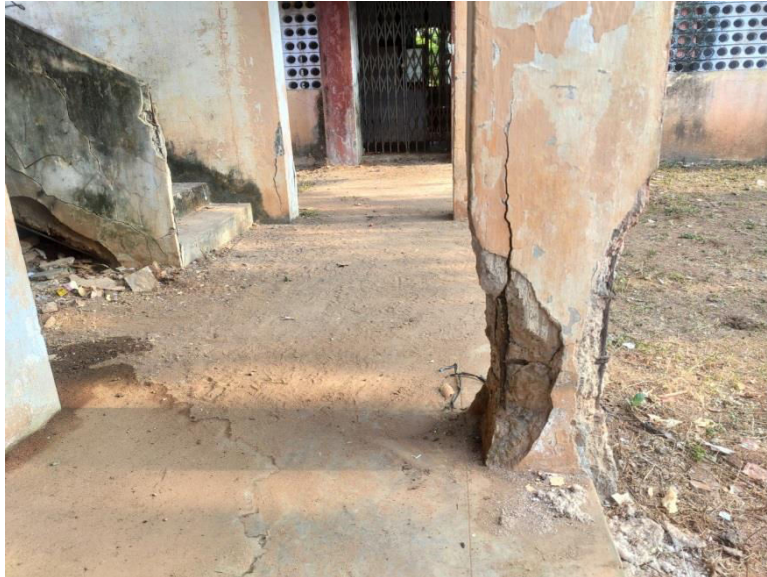
Fig-1 Corrosion crack in column

5.1 Corrosion crack in a column located at thiruvalluvarillam boys hostel (ACGCET), karaikudi.

Type of crack: Corrosion crack in the column.

Cause of corrosion: Inadequate bond between concrete and steel bars are the cause of corrosion of reinforcement in concrete columns. It is also due to the reason of not providing proper cover over the reinforcement.

- Encasement (or) enlargement of the column cross section. (Jacketing)
- Cathodic protection to stop reinforcing steel corrosion
- Chloride extraction to retard the reinforcing steel corrosion.
- Addition of shear collars to increase the shear capacity of intermediate floors.
- The application of a protection system to prevent future corrosion.

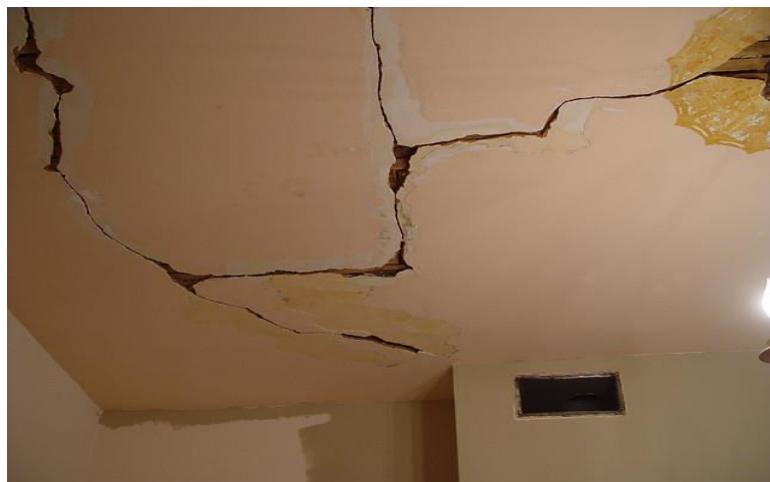
5.2 Flexural crack in the slab in tiruvalluvarboys hostel.

Type of crack: Flexural cracks on slab.

Cause of corrosion: External load results in direct and bending stresses, causing flexural, bond and diagonal tension cracks. Immediately after the tensile stress in the concrete exist its tensile strength, internal micro cracks propagating to the external fibre zones of the concrete element.

- The use of embedded CFRP reinforcement through the stirrups is a very promising, practical and sufficient method of repairing especially in corroded steel R.C. beams as it could increase the beam capacity after repairing and also could be easy in construction as the concrete cover in most corroded beams has already been spalled out.

- The use of embedded CFRP reinforcement prohibited any concrete cover delamination could occur using near surface mounted method.
- The use of embedded FRP rods is an effective technique to enhance the flexure capacity of R.C. beams. An increase in capacity by 33.33% with respect to the control beam could be obtained.
